Evaluation of
The Gutter Topper®, LTD
Leaf and Debris Gutter Protection System
in Accordance With
Dade County Protocol TAS 100(A)-95 (Modified)
TEST PROCEDURE FOR WIND AND WIND DRIVEN RAIN RESISTANCE
AND/OR INCREASED WINDSPEED RESISTANCE OF SOFFIT
VENTILATION STRIP AND CONTINUOUS OR INTERMITTENT
VENTILATION SYSTEM INSTALLED AT THE RIDGE AREA

Dade County Building Code Compliance Office PROTOCOL PA 100(A)-95 (Modified)

TEST PROCEDURE FOR WIND AND WIND DRIVEN RAIN RESISTANCE AND/OR INCREASED WINDSPEED RESISTANCE OF SOFFIT VENTILATION STRIP AND CONTINUOUS OR INTERMITTENT VENTILATION SYSTEM INSTALLED AT THE RIDGE AREA

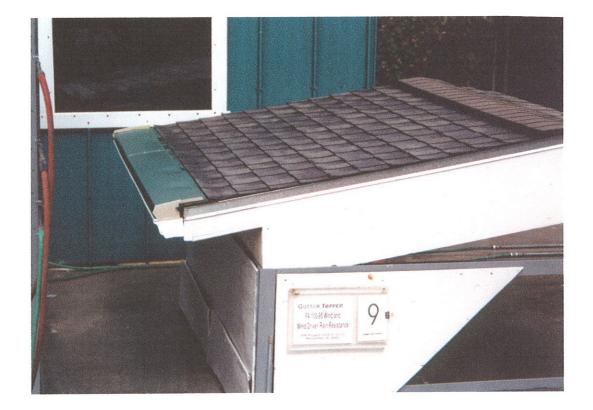
1.5.1 Photograph of Deck Immediately Prior to Commencement of Testing.

The Gutter Topper was installed per the manufactures installation instructions. The Gutter Topper was fastened to the gutter with painted $\frac{1}{4}$ x $\frac{1}{2}$ inch hex head corrosion resistant sheet metal screws placed 12 inches on center where the Gutter Topper contacted the outside edge of the gutter. The Gutter Topper test sample was fastened to the roof by lifting the second course of shingles and placing #8 x 1 inch flat head corrosion resistant screws 12 inches on center. The lifted shingles were re sealed with GEOCEL sealant. The Gutter Topper end terminations (caps) were fastened to the Gutter Topper with (3) $\frac{1}{4}$ x $\frac{1}{2}$ inch hex head corrosion resistant sheet metal screws at each termination. The Gutter Topper test sample incorporated an end lap joint and gutter end terminations.
