Laboratory Report

Report for: Gutter Topper LTD 605 E. Ohio Pike Amelia, OH 45102 Date: March 15, 2002

- Attention: A. M. Ianelli
- **Purpose:** The purpose of this project was to determine the resistance of Gutter Topper[®] leaf and debris gutter protection system to clogging with a mix of naturally occurring debris as well as to determine the load bearing capabilities of the installed system.

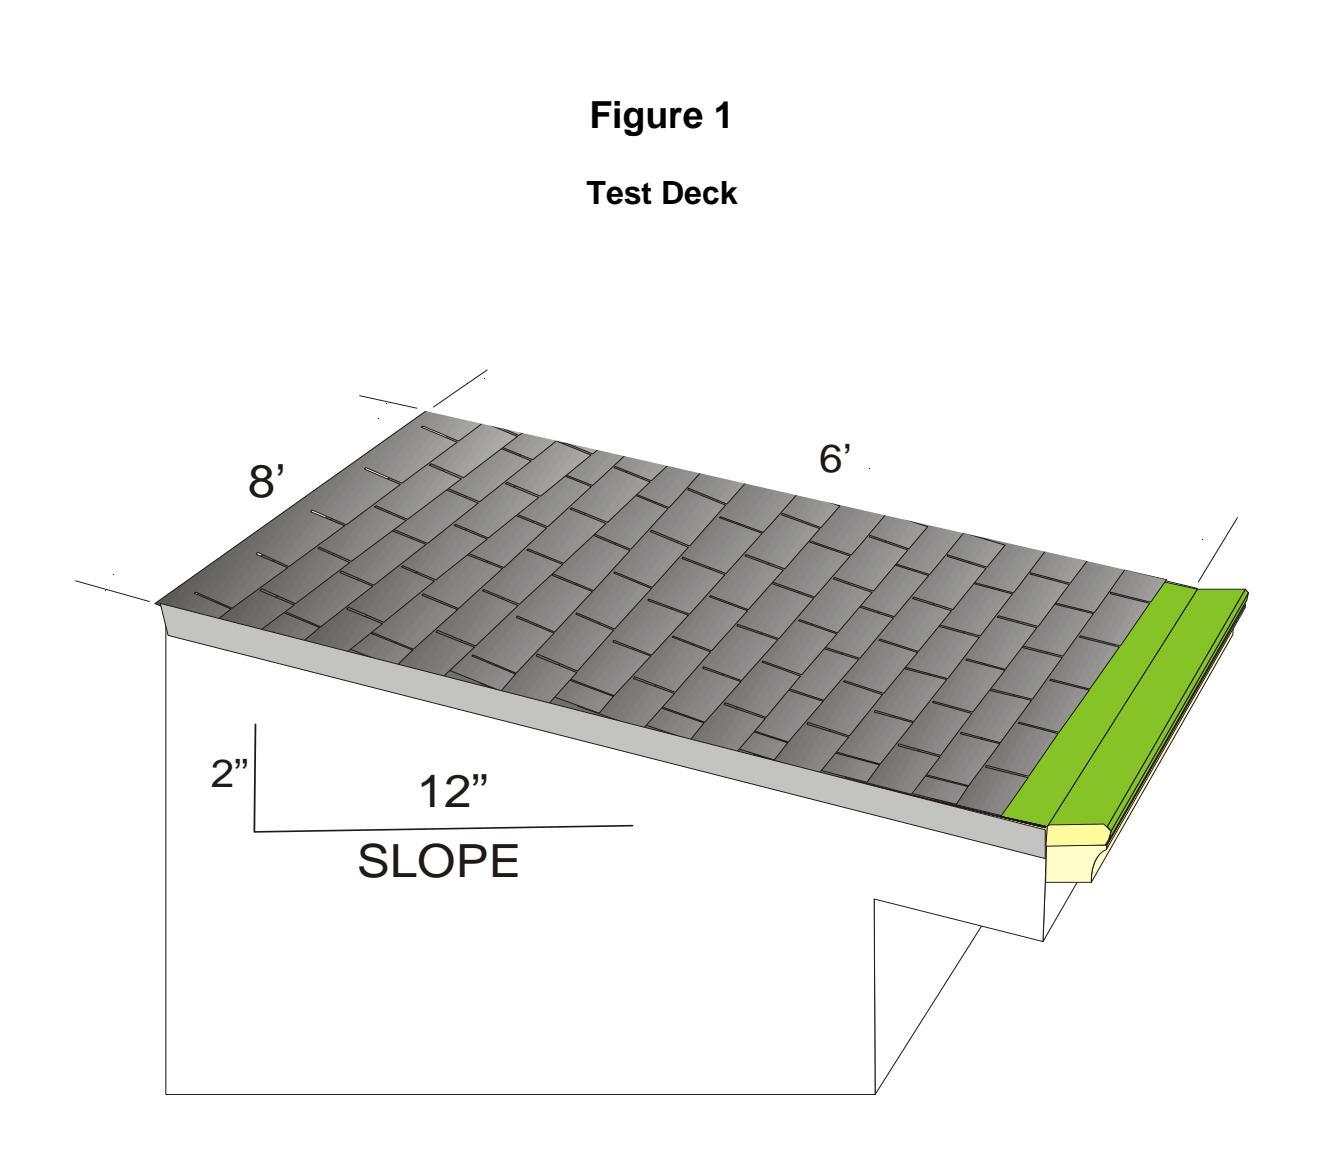
The 48 square foot test deck was constructed to be 8 feet wide at the ridge and 6 feet from ridge to eave. The roof pitch was 2 inches in 12 inches. The test deck was constructed with 8 inch of fascia and 12 inches of soffit. A 5-inch wide by 3-1/4 inch deep, painted 0.029 aluminum gutter was installed at the 8-foot eave. The gutter brackets supporting the gutter were placed 24 inches on center. Gutter and mounting hardware was purchased at a local distributor and installed per the manufactures installation instructions.

The Gutter Topper was installed per the manufactures installation instructions. It was fastened to the gutter with painted $\frac{1}{4} \times \frac{1}{2}$ inch hex head corrosion resistant sheet metal screws placed 12 inches on center where the Gutter Topper contacted the outside edge of the gutter. The Gutter Topper test sample was fastened to the roof by lifting the second course of shingles and placing #8 x 1 inch flat head corrosion resistant screws 12 inches on center through the unit and into the deck. The Gutter Topper end terminations (caps) were fastened to the Gutter Topper with three, $\frac{1}{4} \times \frac{1}{2}$ inch hex head corrosion resistant sheet metal screws at each termination. The Gutter Topper test sample incorporated an end lap joint and gutter end terminations. See Figure 1.

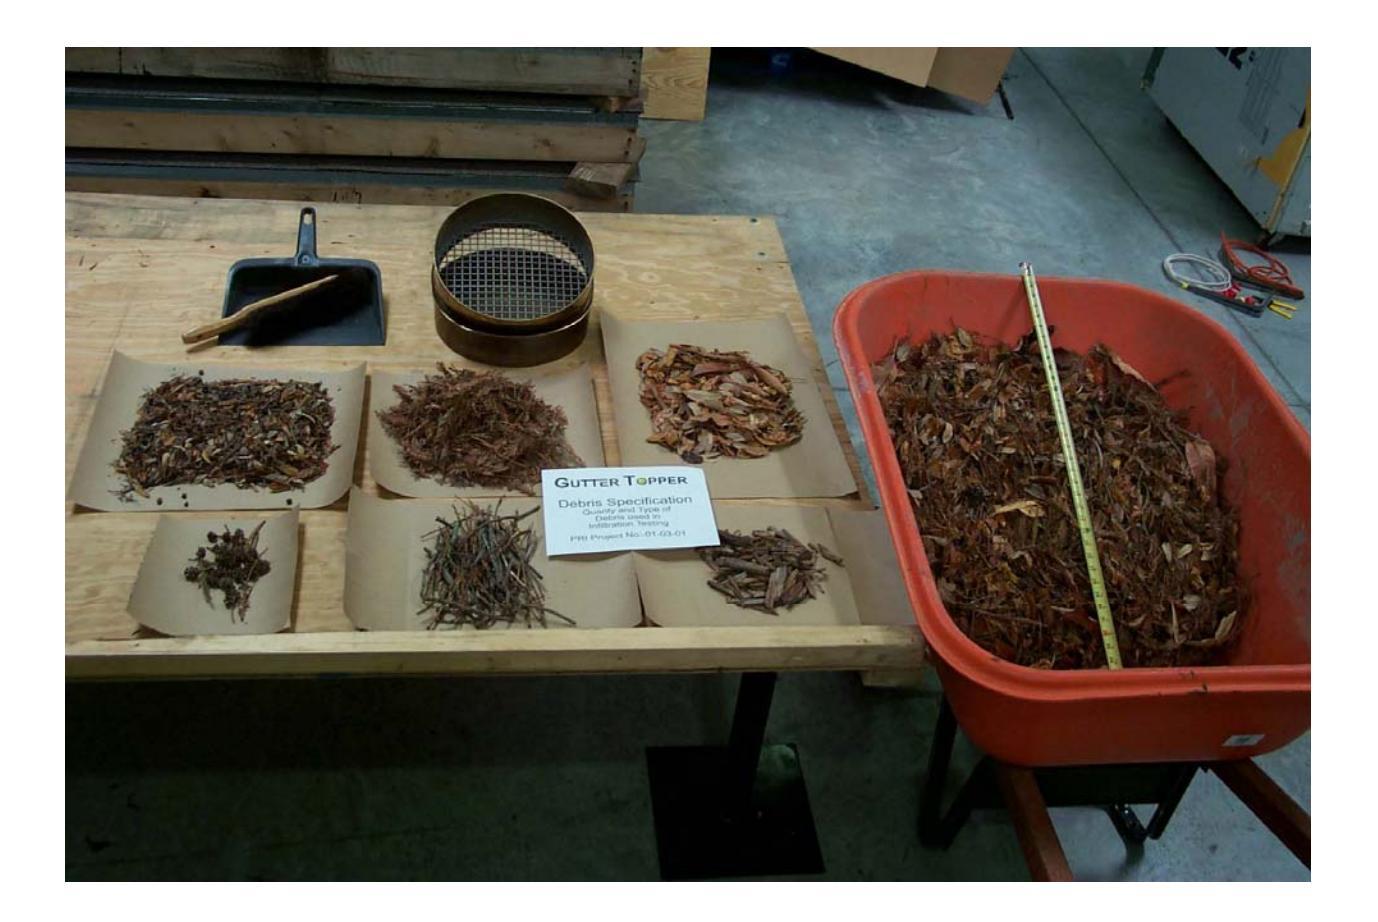
Test Debris Description and Quantification

Test Debris Quantification

Approximately ten pounds of typical roof debris was collected and hand mixed in a large wheelbarrow. A sample was removed from the mix and sieved to remove the fine debris. The material which did not pass a $\frac{1}{2}$ " sieve was sorted by type of material. The fractions were weighed and the weights recorded. The components of the debris were recombined and dried in an oven at 180°F to a constant weight to determine the moisture content.

Material	Description	Weight In grams	Percentage of mix		
Leaves	Largest dimension between		1" and 9" inches	138.4 g	10%
Bark	Ranging in width between Ranging in length between	1/4 and 1 inch 1/4 and 4 inches	230.3 g	17%	
Twigs	Ranging in diameter between Ranging in length between		1/16 and 1/2 inch 1-1/2 and 14 inches	232.7 g	17%
Pine Needles	Ranging in length between	1-1/2 and 10 inches	219.2 g	16%	
Mix of leaves, bark, twigs, and pine needles.			Passing 1/2" sive	540.2 g	40%
Debris mix moisture content 12%			Total weight	1360.8 g 3 lbs.	100%

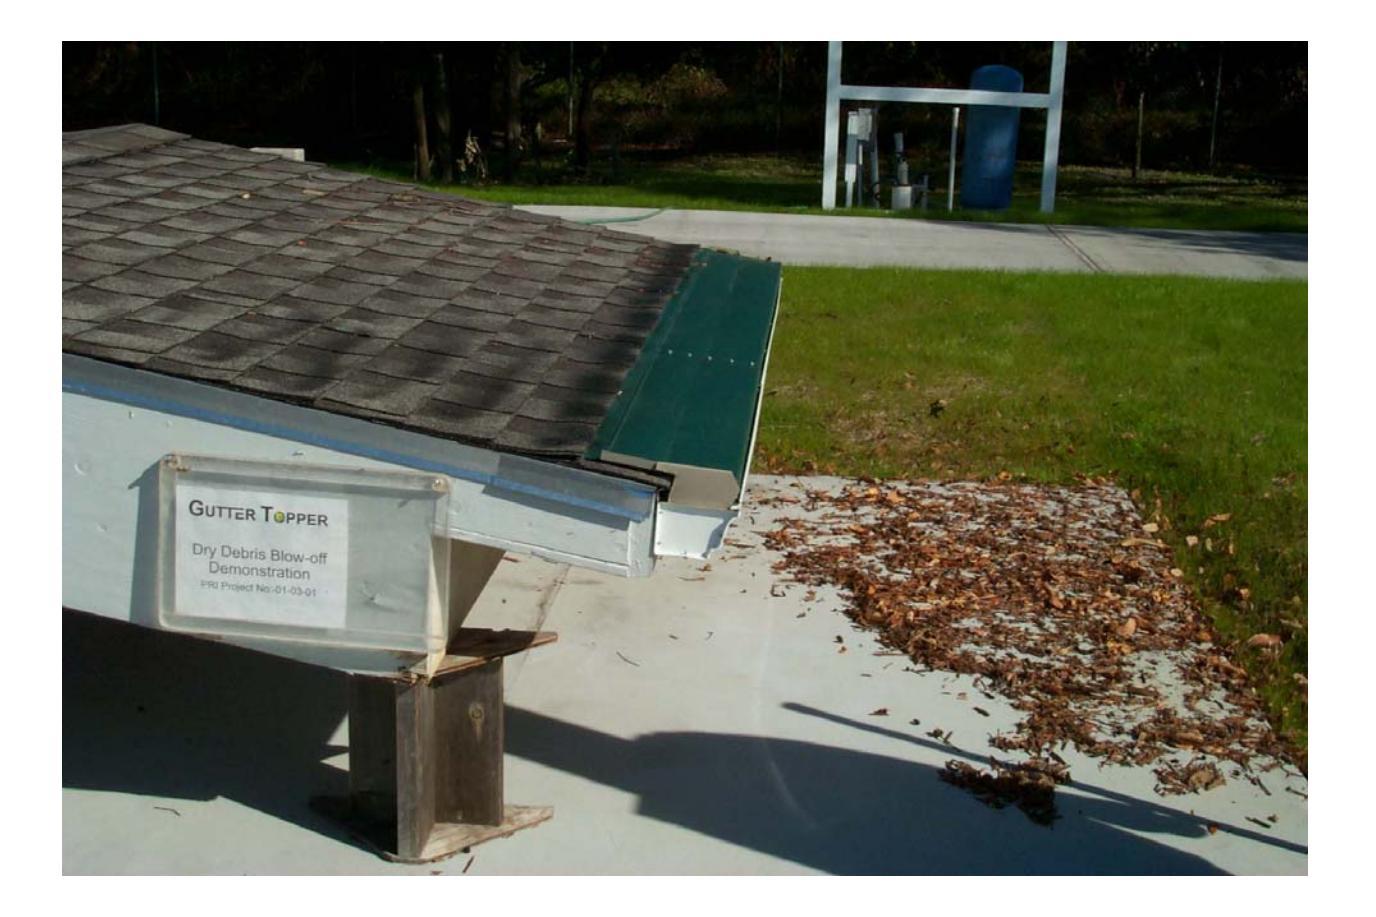
After Dry Debris Trapping Test

Three pounds of the debris mix, at 12% moisture, was uniformly applied to the test deck. Debris blow off was accomplished with the leaf blower held 12 feet from the ridge of the test deck and aimed down slope towards the gutter cover being tested. Sweep deck until debris is removed. After completing the blow off, the Gutter Topper unit was examined for debris.

Results: No debris was found in the Gutter Topper cover or in the gutter.

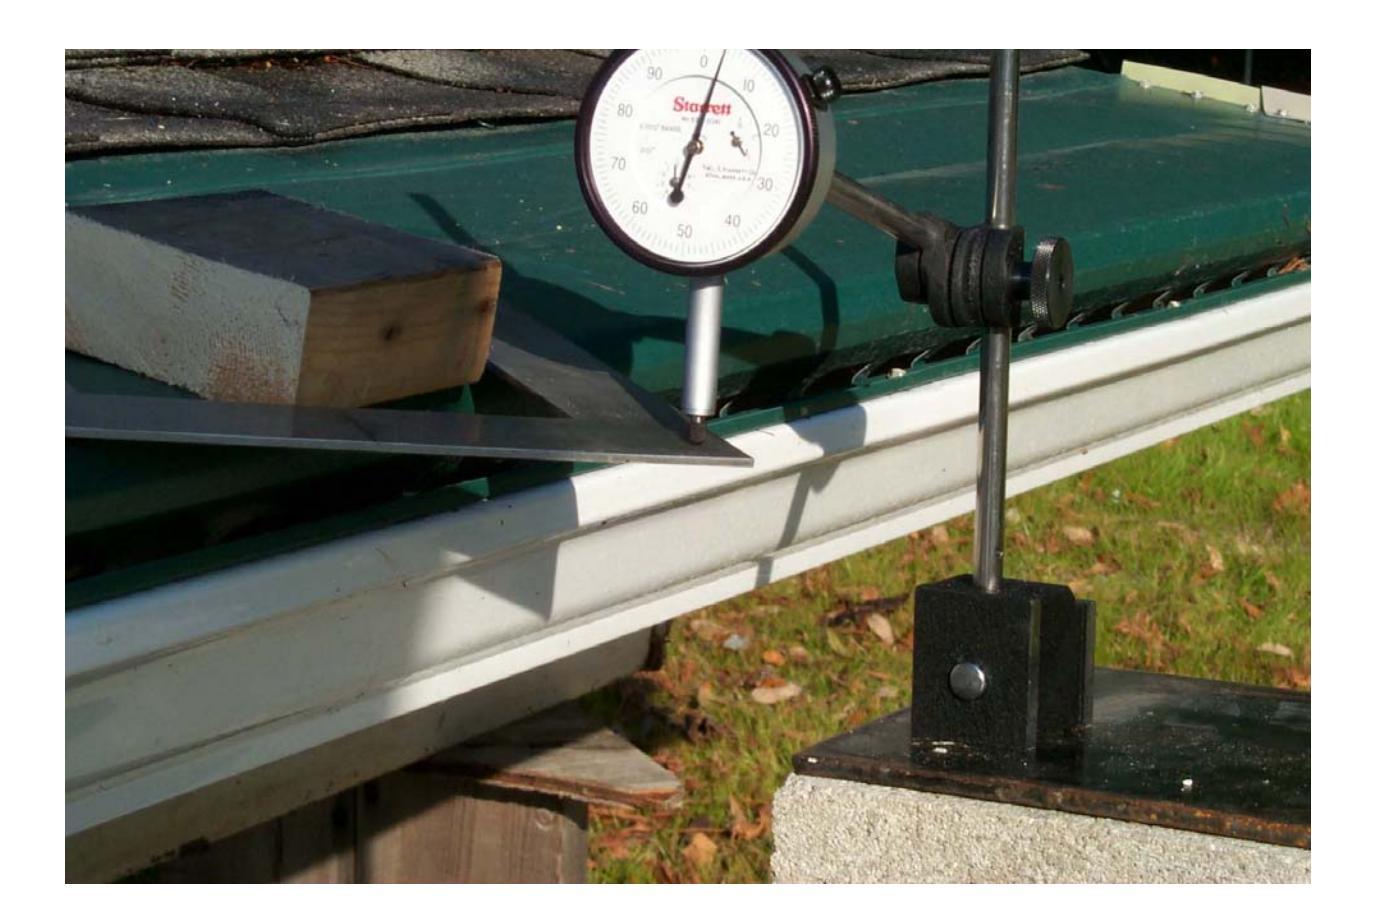
Load bearing capability

Load Bearing Capability Setup

The load bearing capabilities of the installed system was determined by applying weight to a 3 inch by 4 inch block of wood placed with the 4 inch dimension at and parallel to the outside edge of the gutter cover and centered between the gutter brackets. Loading was applied to the block until either the gutter cover openings closed due to deflection or the supporting gutter deflected, deflection and return values were measured and recorded.

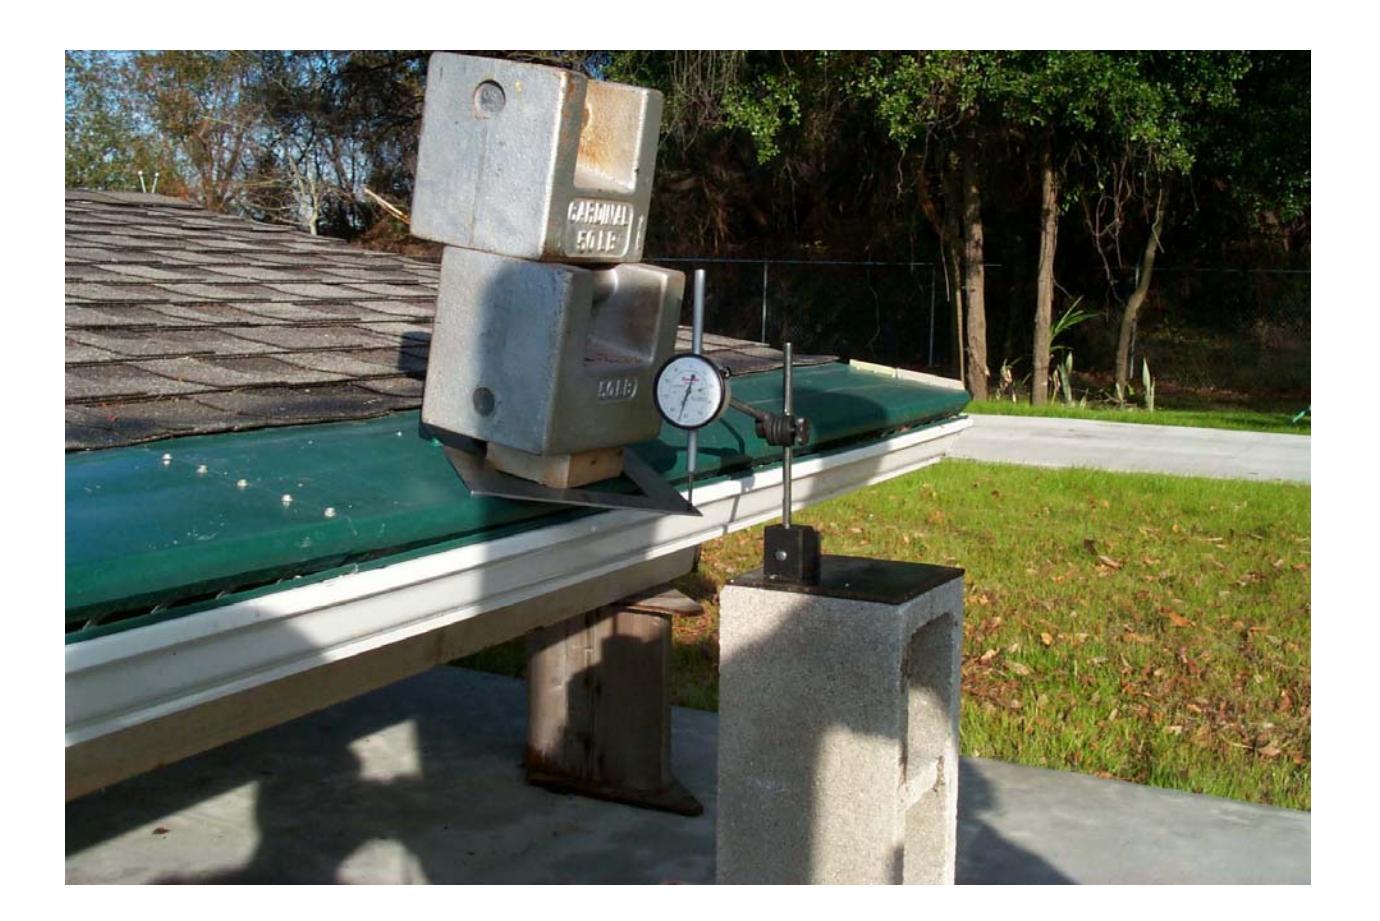
Load bearing Capability at Maximum Load

Gutter Topper	Load lbs.	Load, Pounds per lineal foot	Load, Pounds per square foot psf	Deflection, inches	Recovery from deflection
INITIAL LOADING	50	150	600	0.375	100%
MAXIMUM LOAD	100	300	1200	0.525	95%

(Could not completely close water entry opening, the supporting gutter deflected leaving a 1/8" opening.)
